**2005 WJTA American Waterjet Conference  
August 21-23, 2005 • Houston, Texas**

**OFFSHORE WASHDOWN PUMP UNIT  
A MANUFACTURING CASE STUDY**

Weimin Dai, Michael T. Gracey  
Weatherford International Ltd.  
Houston, Texas

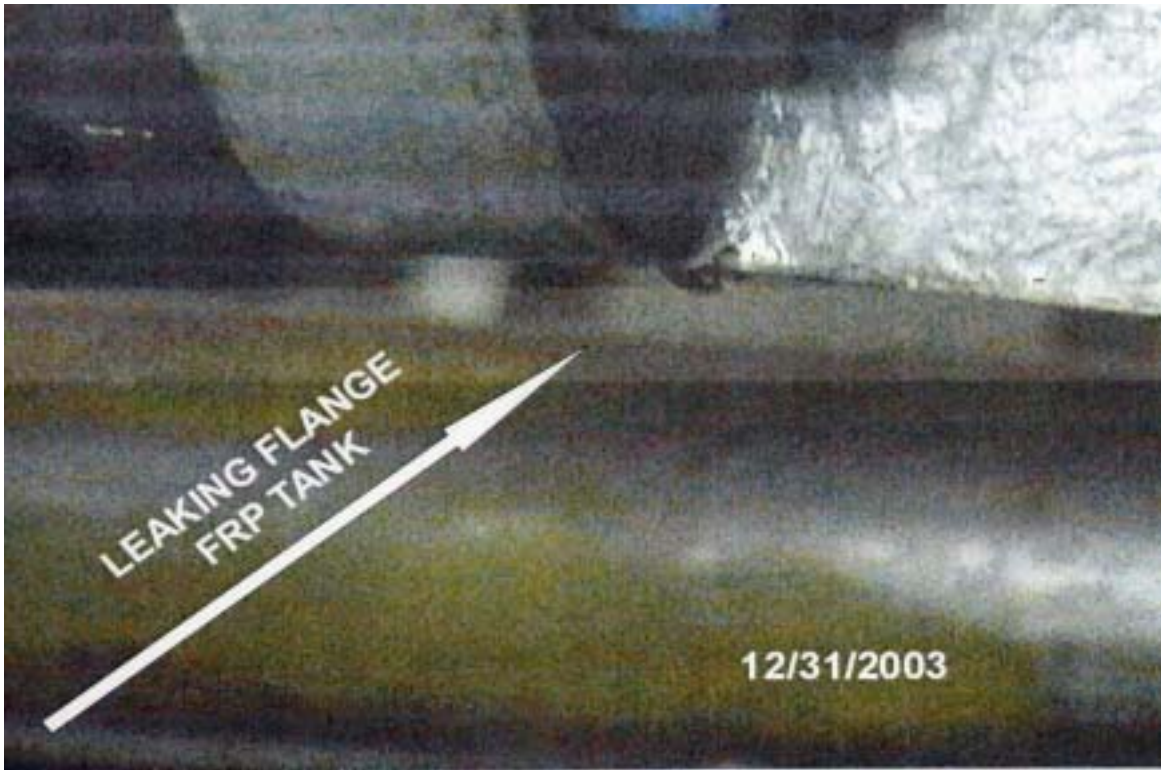
**FIGURE 5 --- FRP Soap Tank Leakage**

Originally, the unit soap tank was quoted as stainless steel, but the customer wanted Fiberglass Reinforced Plastic (FRP). During testing, water was dripping at the flange connection of the Soap Tank (see Figure 5). Cracks were visible to the naked eye and appeared to have traveled into the neck of the FRP flange (see Figure 6). Cracks were visible on both flange connections. It was determined that incorrect tightening of the flange bolts was the main cause of the leakage and low strength FRP itself (compared to steel tank) also contributed to the failure. The FRP Soap Tank was then removed from the skid and sent back to the tank vendor to repair. The Raised face flange was then changed to a flat-faced flange and rubber gaskets were used. Inner tubing of the neck/flange was replaced and remolded into the tank body. After repairing, the FRP soap tank was hydrostatically tested for four hours. The support for the FRP tank on the skid was also redesigned. No more leakage was found during subsequent tests.

The same problem was encountered in the first unit (FRP tank broken) and why it happened to the second unit. The change of vendor and project team contributes to a repeat of the problem encountered on the first unit.
