**UTILIZING WATERJET TECHNOLOGY TO MITIGATE SUBSTRATE
DAMAGE WITHIN UNDERGROUND STRUCTURAL LINERS
DURING REHABILITATION WORK**

J. Bourgeois, H. Miller, E. Charrier
Colorado School of Mines
Golden, CO

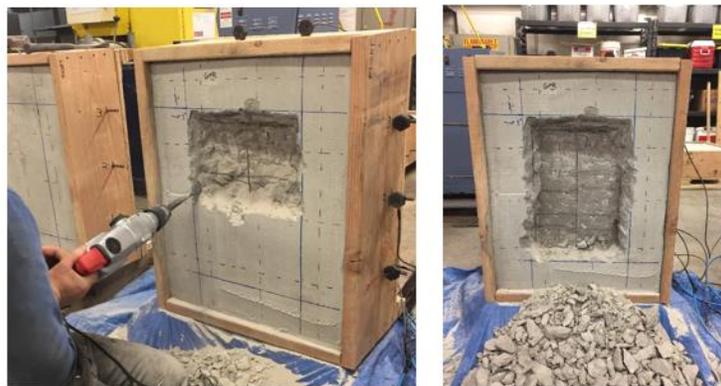
Figure 2. Process of mechanical excavation using impact hammer

Mechanical excavation was conducted at the EMI using an electric rotary hammer. The sample was turned on end, so the exposed concrete face was vertical in order to better simulate repairs to the rib. A Bauer 40-millimeter (1-9/16-inch) rotary hammer (1643E-B) was used. It was rated at 3,780 impacts per minute with a force of up to 6.6 foot-pounds per impact. Excavation was conducted using a 2.54-centimeter (1-inch) concrete spade chisel. Bit rotation was disabled to allow for better operator control of the chisel location and orientation and to simulate common repair practice. A rectangular cavity was cut in the center of each panel and excavated to the top of the concrete layer. The mechanical excavation process is shown in Figure 2.

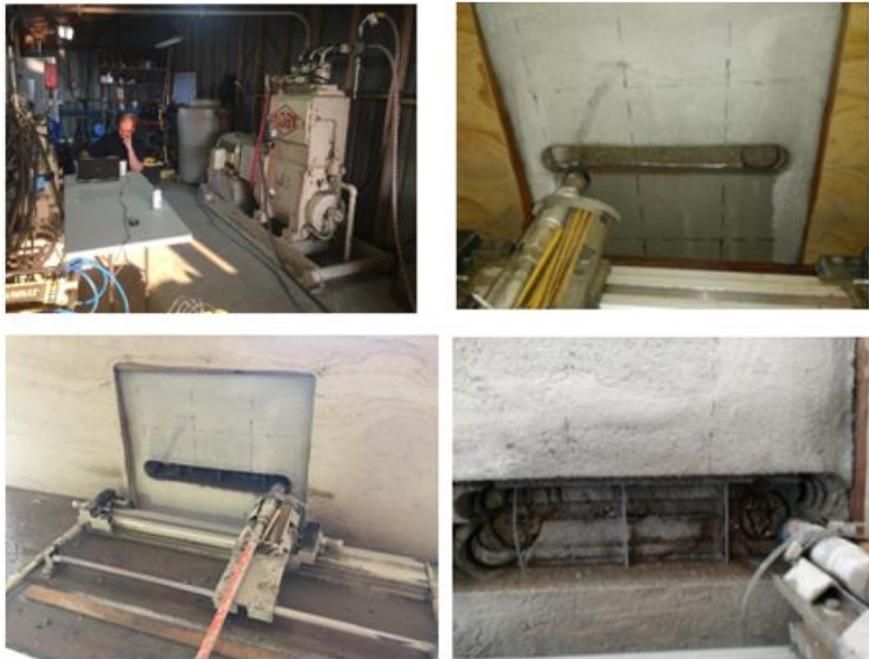
Figure 4. Waterjet excavation – Laboratory set-up (upper left) start of slot in panel (upper right) kerf in panel (bottom left) close-up of kerf in panel (bottom right)

A twin orifice rotary nozzle assembly was utilized with two commercially purchased 0.74 millimeter (0.029 inch) diameter stainless steel leach walker type nozzles with vane flow straighteners. These nozzles were chosen based on their pressure and flow ratings of 151.7 MPa (22,000 PSI) and 12.9 lpm (3.4 gpm) respectively. Overall, the size and design of the nozzles used for this research was chosen based on empiric experience and the need to maintain jet stagnation pressures above the potential threshold pressures of the target material. The nozzle assembly was connected to the pump accumulator via a 3.7-meter (12-foot) long, 5.1-millimeter (0.2 inch) ID, 275.8 MPa (40,000 PSI) high pressure flexible hose. The system includes a bypass valve at the pump which was designed to regulate flow and pressure. For safety considerations, a pressure relief valve and rupture disc assembly were plumbed into the system. System pressure was measured using a gauge located at the pump accumulator. The pump required an organic lubricant

in the form of a soluble gear oil mixture, which was mixed into the water supply (2% by volume). It is assumed that the addition of the oil into the system possessed negligible effects on the thermal and dynamic properties of the fluid. A summary of operating parameters used during continuous waterjet impingement on the test panels is outlined in Table 2. The cutting system used during waterjet testing is shown in Figure 4.

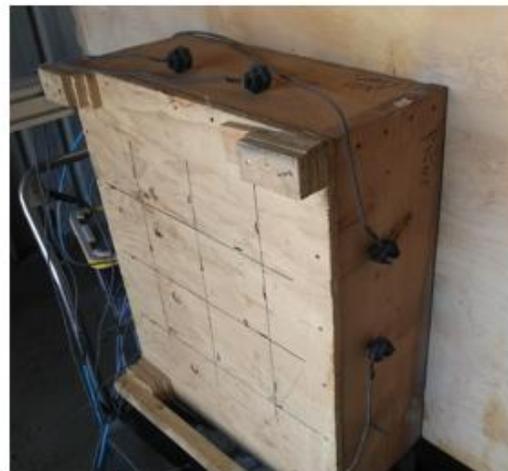
Figure 5. Accelerometer locations (left) accelerometers on actual panel (right)

The data acquisition system (DAQ) recorded vibration readings from seven accelerometers. The accelerometers were mounted on the exposed ends of the rebar in the test panels. A USB DAQ and LabVIEW were used to process and save the collected data to a laptop. The accelerometers used were a prosumer product from Sparkfun, the ADXL337, which is a triple axis analog accelerometer with a range of +/-200 G. The X, Y, Z, ground and +3.3 V connections were soldered to the wiring harness. The ground and +3.3 V were supplied by the National Instruments USB-6211 DAQ. The Z axis and the X axis were used on each accelerometer due to the limited number of analog channels available. The Z axis was normal to the sample surface with +Z pointing towards the excavation equipment. The X axis ran parallel to the edge of the sample.

The accelerometers were mounted in enclosed 3D printed ABS sensor mounts. The ADXL337 was attached to the accelerometer mount by four screws. A cutaway was left in the base of the sensor mount for the wiring harness. The sensor mounts were pressed onto the rebar. To ensure a tight fit, the rebar was wrapped with electrical tape. The hexagonal tops of the sensor mounts were parallel to the surface of the panel. Seven sensor mounts were used during testing. These were arranged in a counterclockwise pattern around the sample starting with accelerometer 1 on the bottom right rebar end. There were three accelerometers on the right side of the sample, two on the top of the sample, and two on the left side of the sample. The sensor arrangement is shown in Figure 5.
