2023 WJTA Conference and Expo
October 30-November 1, 2023 • New Orleans, Louisiana

REVIEW OF DEVELOPMENT OF PROFILE BY WATER JETTING
FOR COATINGS REMOVAL

Lydia M. Frenzel, Ph.D.
Advisory Council
lydiafrenzel@outlook.com
Vancouver, WA USA

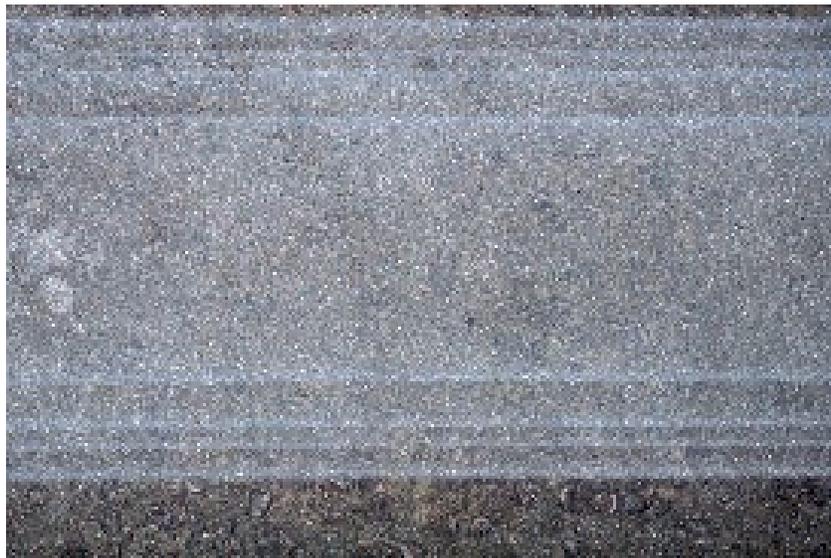
Figure 4 Waterjet cleaning to WJ-1 of Grade D steel. The rotating head standoff was moved further in. Showing the linear groove of the nozzle.

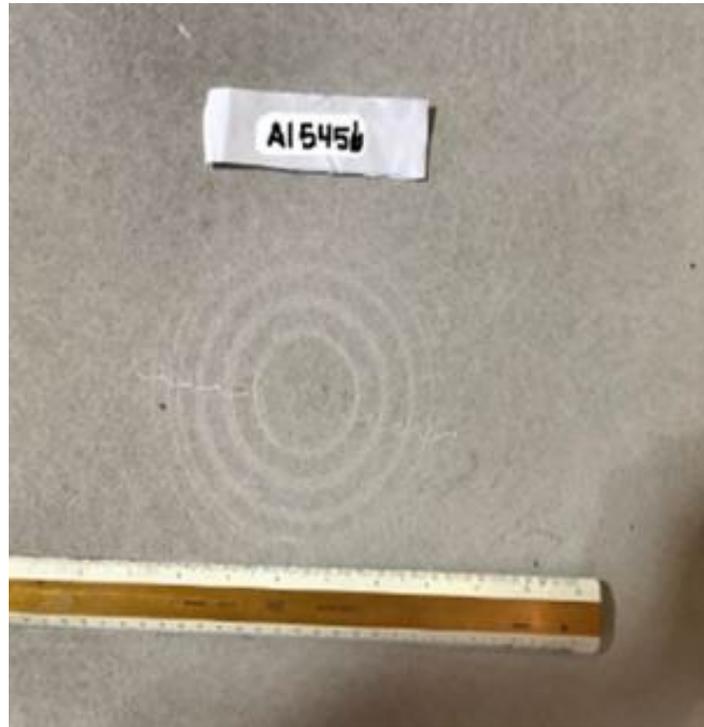
Figure 18 Combination of deep gouges in a linear direction and circular grooves seen into the Al 5456 plate. NSWCCD Figure

The second type of defects as seen in Figure 18 are circular grooves (also called crop circles) that can occur during the UHPWJ process when the robotic crawler unit is left stationary but the ultra-high pressure water is running and the bar is rotating. They can also occur when the operator is

maneuvering the unit back and forth in the same general area. Circular grooves visually revealed into the Al 6061 plate during the cycles of UHPWJ as illustrated in Figures 21 and 22. The circular grooves were examined in more detail during the mass loss trials of Al 6082.
