**2005 WJTA American Waterjet Conference  
August 21-23, 2005 • Houston, Texas**

**SAFE WATERJET CLEANING OF STEEL PROCESS LINES**

D. Wright, J. Wolgamott, G. Zink  
StoneAge, Inc.  
Durango, Colorado, U.S.A.

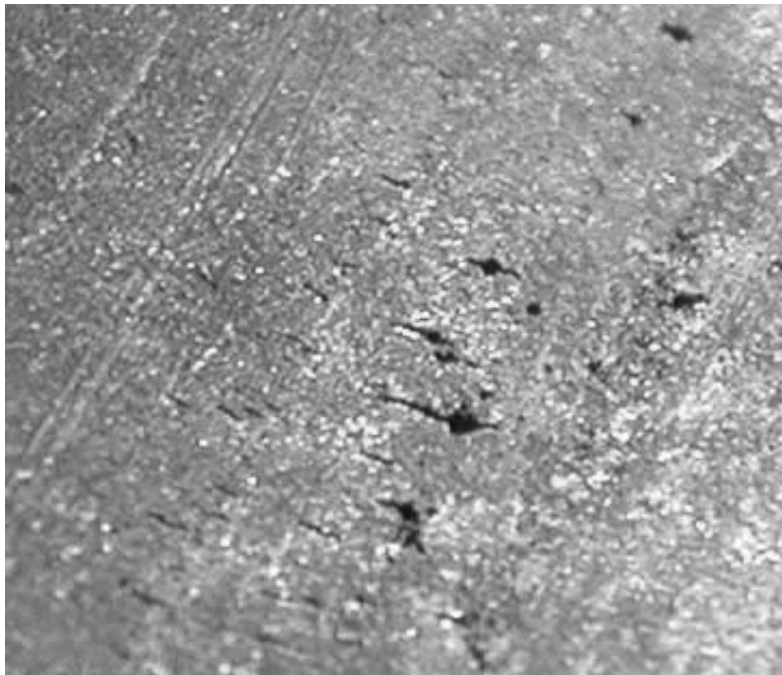
**Detail of Corrosion Pits in Stainless Steel Tube  
Figure 2.**

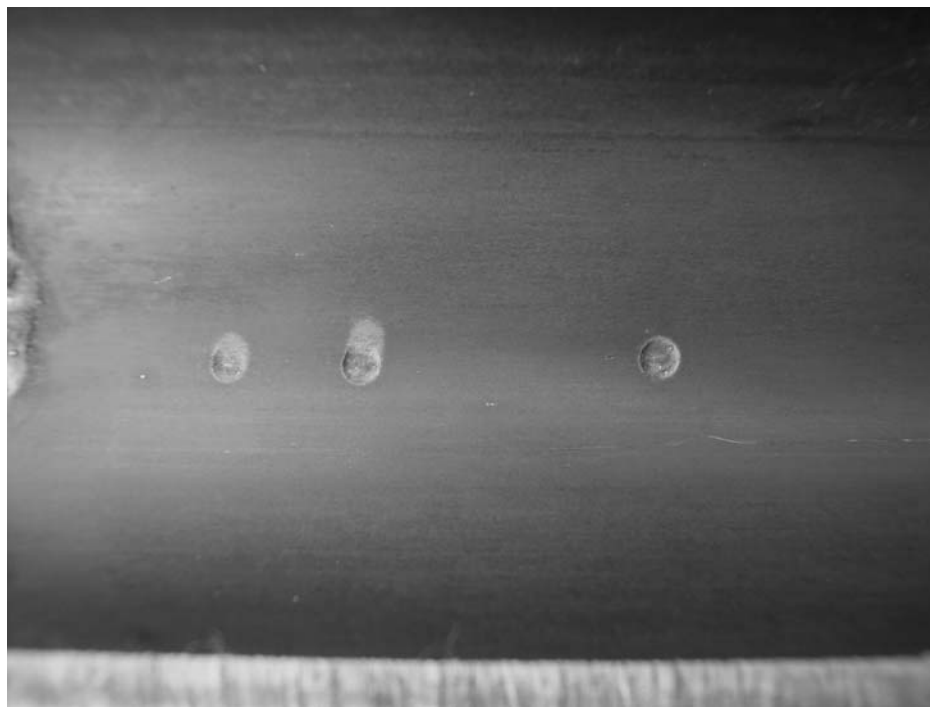
**Damage to Carbon Steel Tubing, at 140 MPa (20,000 psi) with Stationary Drilled Steel  
Nozzle, for Time Periods of 10, 30 and 60 Seconds  
Figure 4.**

The first of these tests used a poor quality drilled steel nozzle orifice, typical of small tube cleaning nozzles without replaceable inserts. An orifice size of 1.07 mm (.042 in.) was drilled at 90° in the head and tested with the jet perpendicular to the tube wall, at a standoff distance of 9.6 mm (.38 in.) Tests were run on both carbon steel and stainless steel for periods of 10, 30 and 60 seconds at pressures of 70, 105 and 140 MPa (10,000, 15,000, and 20,000 psi). Figure 4 shows the damage created at 140 MPa (20,000 psi) with a drilled jet in carbon steel; the carbon steel results are graphed in Figure 5. Figure 6 is a photograph of the damage created at 140 MPa (20,000 psi) in stainless steel; the stainless steel results are plotted in Figure 7. Note that there is very little difference in results between the two materials. At 70 and 105 MPa (10,000 and

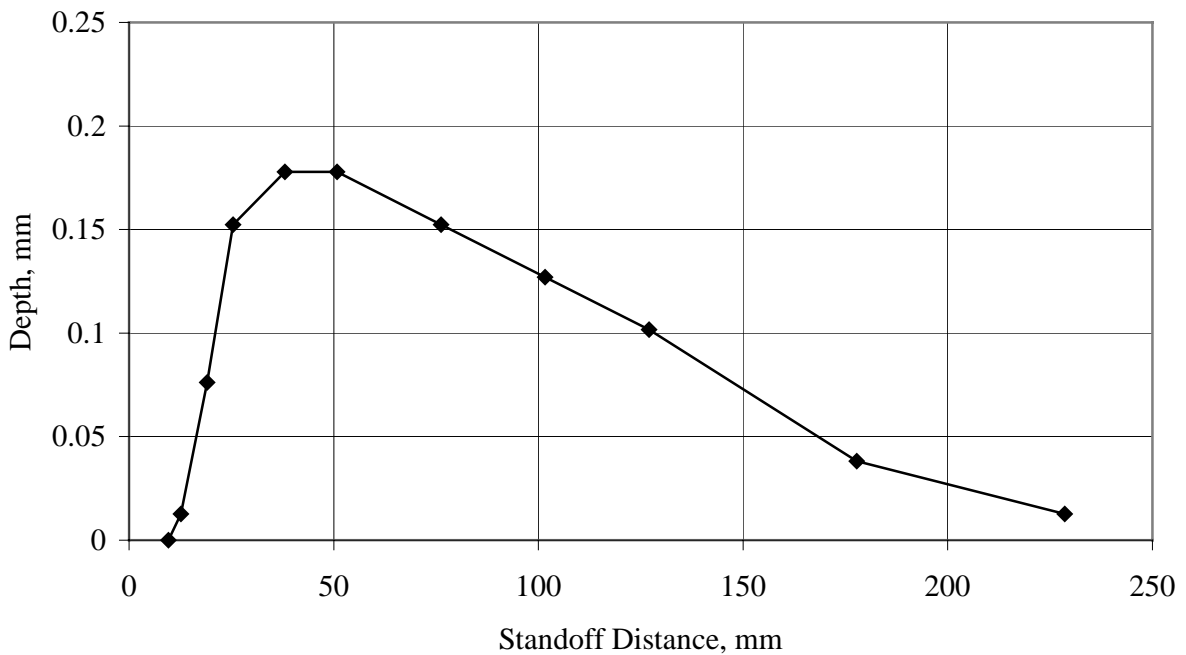
**Effect of Standoff Distance with a Stationary High Quality Steel Nozzle  
With a Flow Straightener at 105 MPa (15,000 psi)  
Figure 8.**

The next series of stationary jet tests used a high quality steel nozzle with a flow straightener and an orifice diameter of .97 mm (.038 in.), exiting from a nozzle head at 90° to the tube wall. Due to the nature of the cavitation mechanism by which the waterjet damages the tube wall, this more coherent jet did not produce any damage up to or including 140 MPa (20,000 psi) after 60 seconds when the standoff distance was 9.6 mm (.38 in.) from the tube wall. Cavitation and damage did occur when this nozzle was tested with increasing standoff distance at 105 MPa (15,000 psi) for 30 seconds at each point. These results are shown in Figure 8.

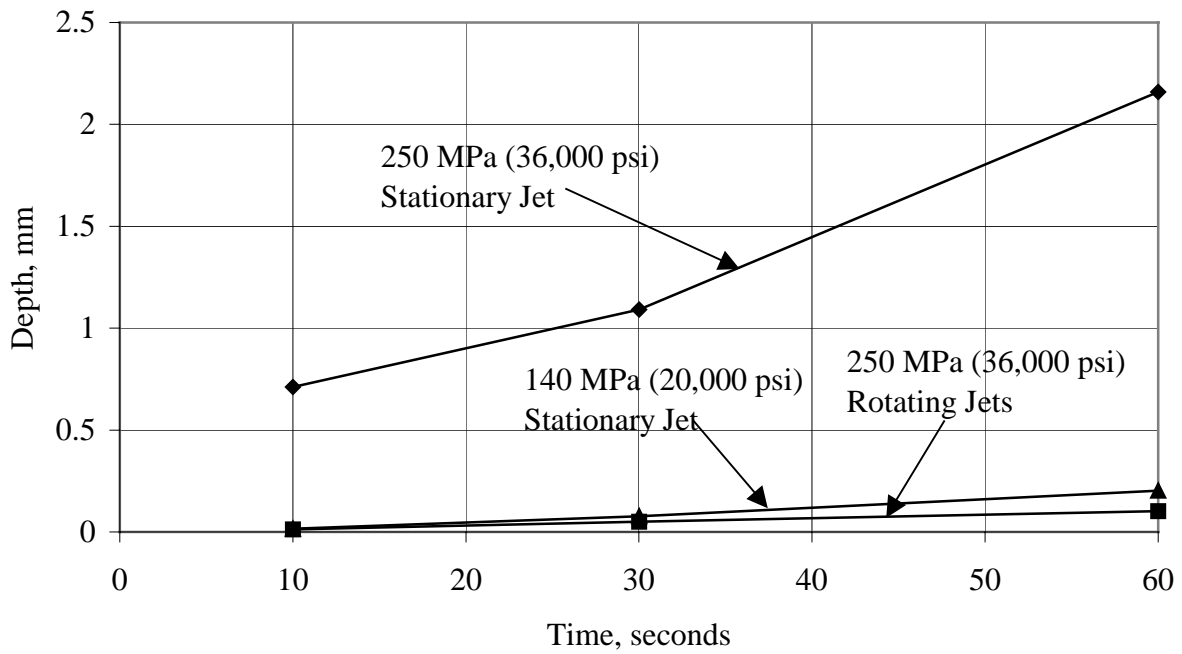
**Rotating Jet Damage Compared to Stationary Jet Damage  
Figure 11.**

Use of rotation as a means of keeping the jet moving over the surface can greatly reduce or eliminate damage to steel tubes and pipes. Figure 11 illustrates the great difference between rotating and stationary jet damage; a stationary jet at 140 MPa (20,000 psi) can cause more damage than rotating jets at 250 MPa (36,000 psi).

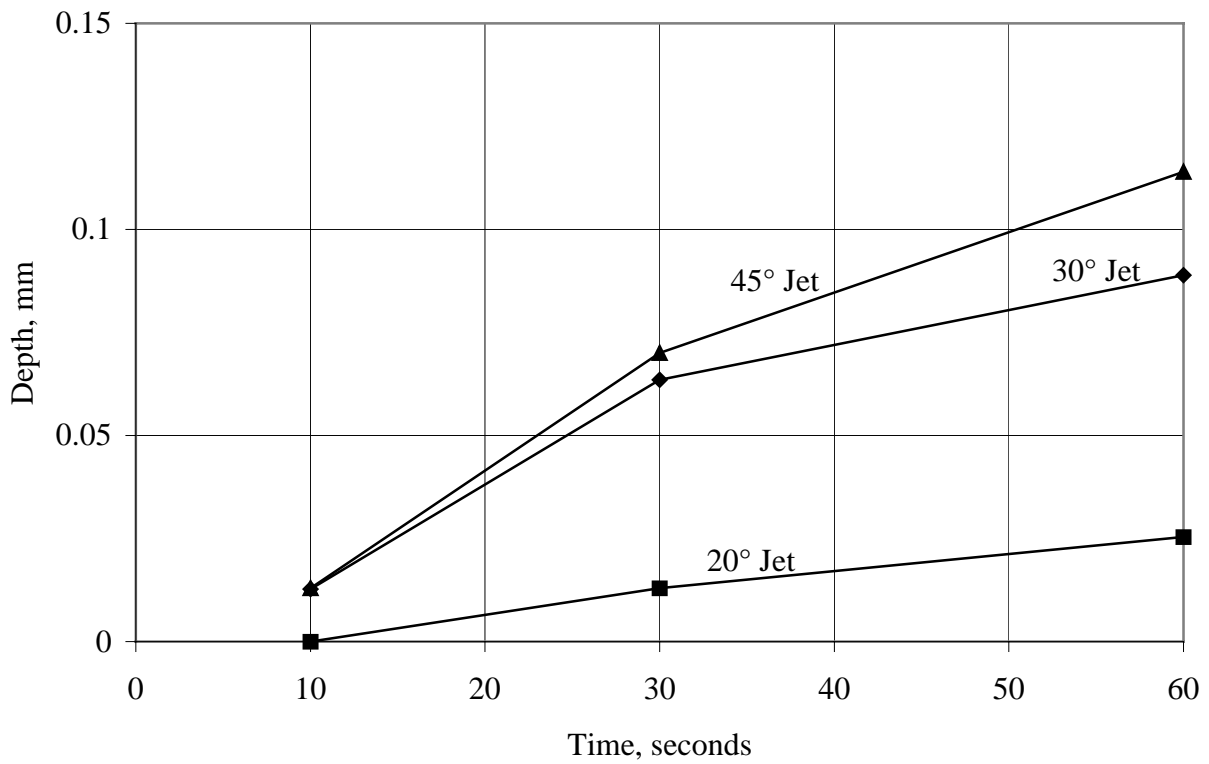
**Effect of Jet Impingement Angle at 250 MPa (36,000 psi) with Single Rotating Jet  
Figure 16.**

The effect of jet angle of impingement on the tube wall was studied at 250 MPa (36,000 psi) with rotating jets to determine if a shallow angle resulted in reduced damage. A single .61 mm

(.024 in.) sapphire nozzle was used. At 10 degrees, no damage occurred after 60 seconds of exposure, but a small amount of damage did begin to occur at 20 degrees after 30 seconds, and after 10 seconds with a 30 degree angle. These results are shown in Figure 16.
