**2005 WJTA American Waterjet Conference  
August 21-23, 2005 • Houston, Texas**

**OFFSHORE WASHDOWN PUMP UNIT  
A MANUFACTURING CASE STUDY**

Weimin Dai, Michael T. Gracey  
Weatherford International Ltd.  
Houston, Texas

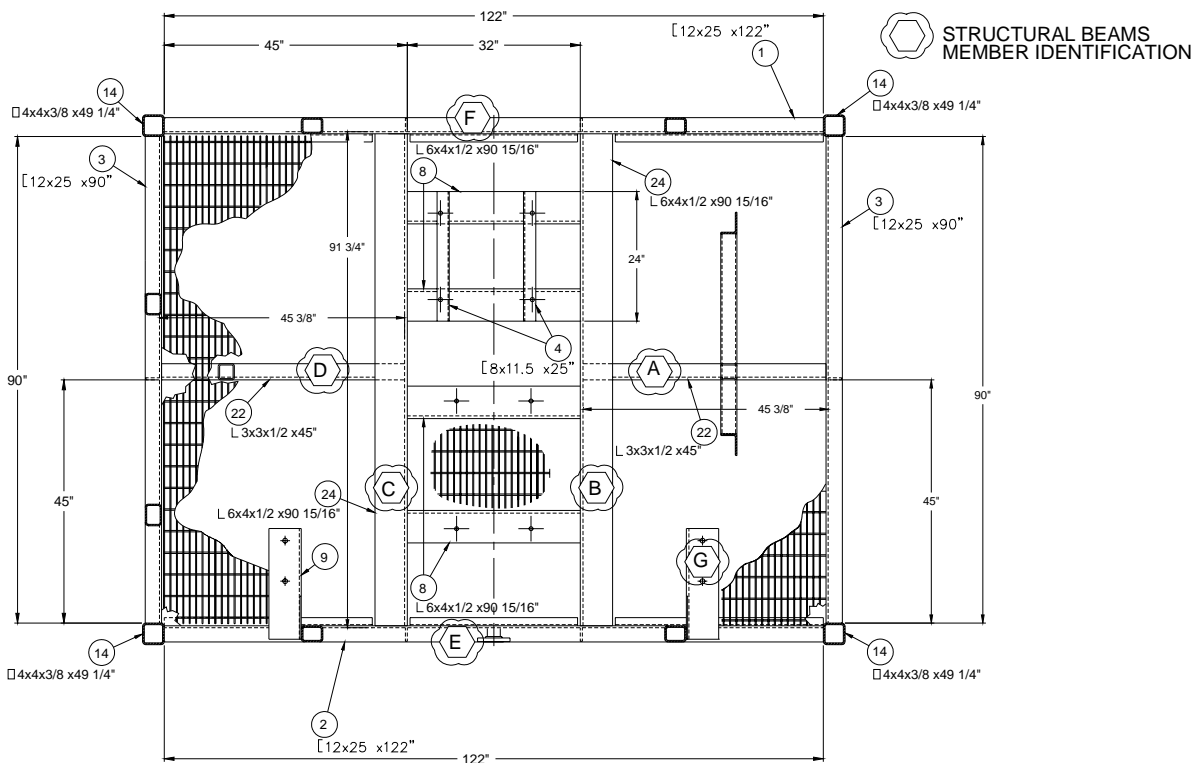
**FIGURE 4 --- SKID STRUCTURAL STEEL CALCULATION**

To the engineering calculations, the customer demanded a redo of all the items involved even very small changes. For example, the customer required new engineering structural steel calculation for the skid due to change from tubing to angles and 2” dimension difference. Some calculations for the Figure 4, skid structure steel calculation are listed below:

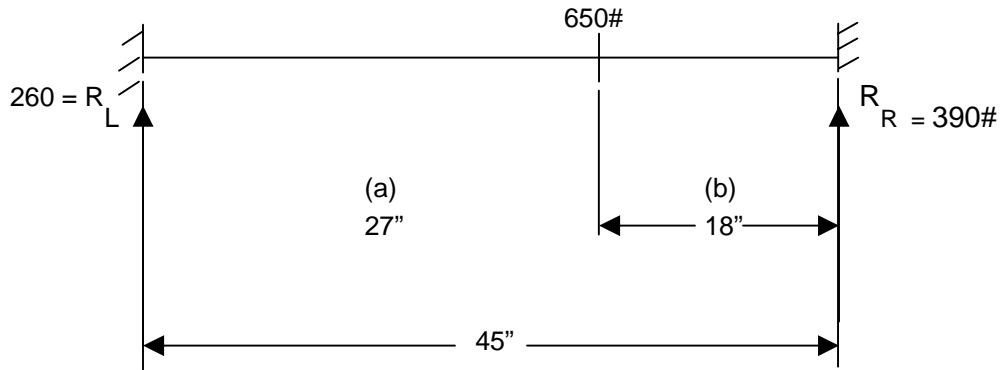
Angle **A** L3X3X1/2,  $S = 1.1 \text{ in}^3$   $I = 2.22 \text{ in}^4$

Max. negative stress is at load.

$$\frac{-2W \times 18^2 \times 27^2}{S \times 45^3} = \frac{-2 \times 650 \times 18^2 \times 27^2}{1.1 \times 45^3} = -3063 \quad (\text{Ref. 3, P242})$$

$$3063 < 20,000 \text{ lbf/in}^2$$

Max. stress is at end next shorter segment.

$$\frac{650 \times 27^2 \times 18}{45^2 \times 1.1} = 3829 < 20,000 \quad (\text{Ref. 3, P242})$$

Max. deflection is in the longer segment

$$E = 29,000,000 \text{ lb}_F / \text{in}^2$$

$$L / 720 = 45 / 720 = .0625 \text{ in}$$

$$\Delta = \frac{2W \times b^2 \times a^3}{3EI(L + 2a)^2} \quad (\text{Ref. 3, P243})$$

$$= \frac{2 \times 650 \times 18^2 \times 27^3}{3 \times 29,000,000 \times 2.22 (45 + 2 \times 27)^2} = .004 \text{ in.} < .0625 \text{ in.}$$

SO ANGLE A 3 x 3 x 1/2 IS OK

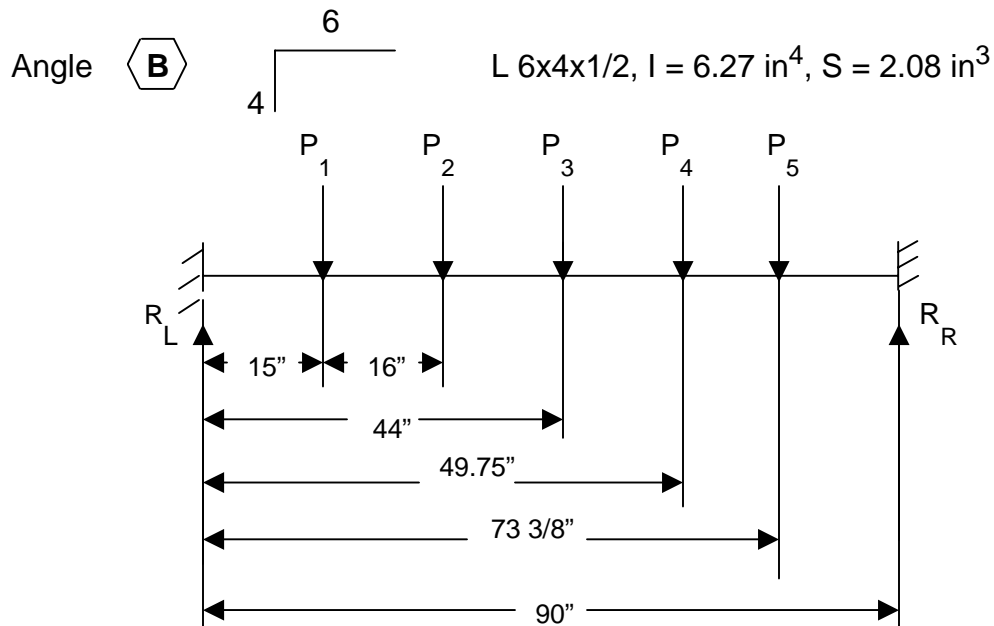
$$P_1 = \frac{\text{PUMP}}{4} + \frac{\text{DIAMPER \& PIPE}}{4} = \frac{772}{4} + 275 = 468\#$$

$$P_2 = \frac{\text{PUMP}}{4} = 193\#$$

$$P_3 @ 44" = 260\# \text{ (SEE CALCULATION FOR ANGLE A)}$$

$$P_4 @ 49.75" = P_5 @ 73 \frac{3}{8}" = \frac{\text{MOTOR}}{4} = \frac{596}{4} = 149\#$$

$$R_R = \frac{15}{90} 468 + \frac{31}{90} 193 + \frac{44}{90} 260 + \frac{49.75}{90} 149 + \frac{73.375}{90} 149 = 475\#$$

$$R_L = 468 + 193 + 260 + 149 + 149 - 516 = 703\#$$

SINCE THE LOAD OF ANGLE B IS SMALLER THAN THAT OF ANGLE C  
PLEASE REFERENCE THE CALCULATION FOR ANGLE C

SO ANGLE B 6x4x1/2 is OK

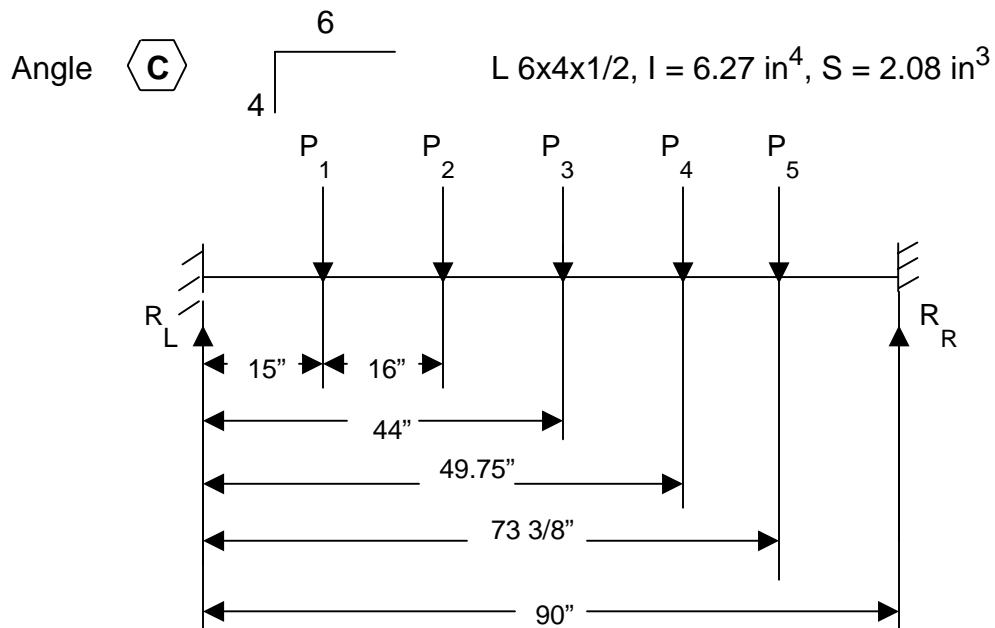
$$P_1 = \frac{\text{PUMP}}{4} + \frac{\text{DAMPENER \& PIPE}}{4} = \frac{772}{4} + \frac{275}{4} = 468\#$$

$$P_2 = \frac{\text{PUMP}}{4} = 193\#$$

$$P_3 @ 44" = 343\# \quad (\text{SEE CALCULATION FOR ANGLE D})$$

$$P_4 @ 49.75" = P_5 @ 73 \frac{3}{8}" = \frac{\text{MOTOR}}{4} = \frac{596}{4} = 149\#$$

$$R_R = \frac{15}{90} 468 + \frac{31}{90} 193 + \frac{44}{90} 343 + \frac{49.75}{90} 149 + \frac{73.375}{90} 149 = 516\#$$

$$R_L = 468 + 193 + 343 + 149 + 149 - 516 = 786\#$$

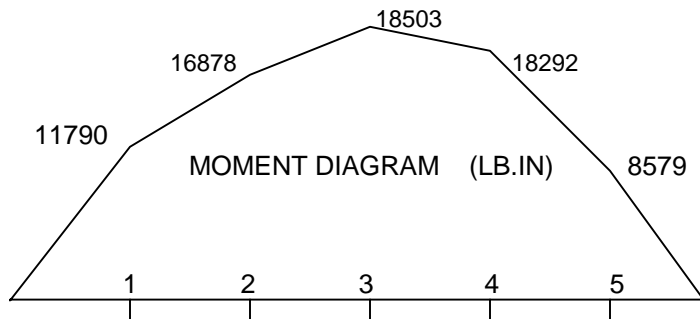
$$M_{\max@P3} = 18503 \text{ lb.in}$$

$$S_{\text{RQD}} = \frac{18503}{20000} = .925 \text{ in}^3 < S = 2.08 \text{ in}^3$$
