**2005 WJTA American Waterjet Conference  
August 21-23, 2005 • Houston, Texas**

**SAFE WATERJET CLEANING OF SEWER PIPE**

D. Wright, J. Wolgamott, G. Zink  
StoneAge, Inc.  
Durango, Colorado, U.S.A.

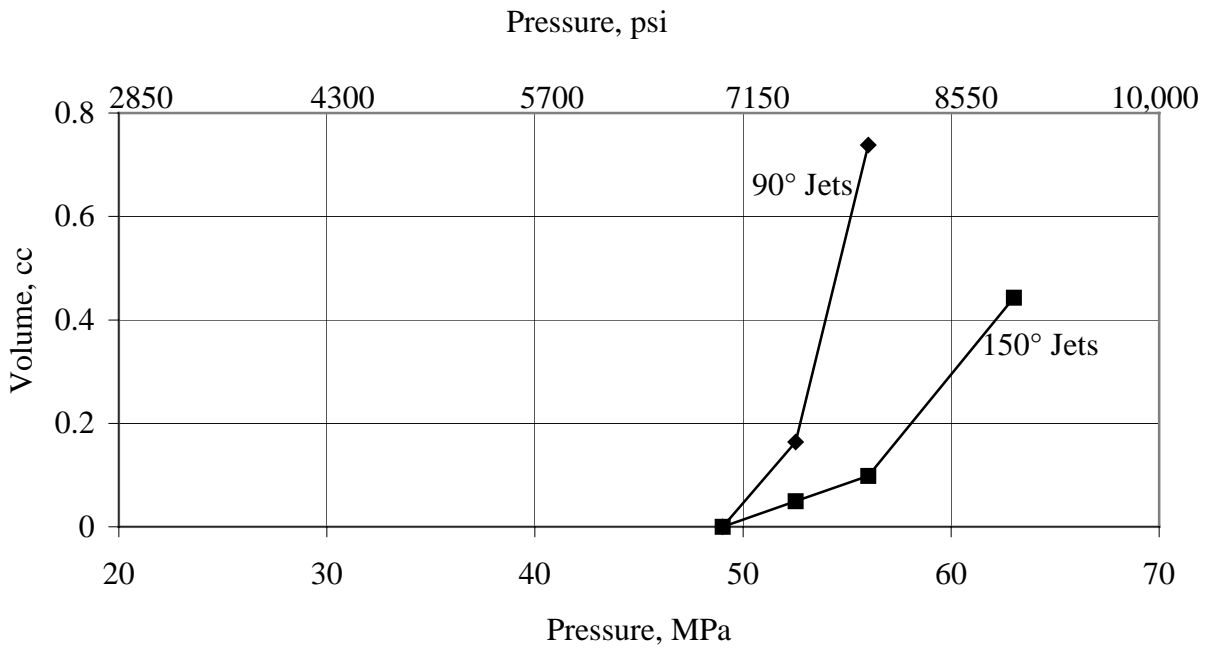
**Effect of Pressure and Jet Angle on HDPE Pipe  
Figure 8.**

pressure of 49 MPa (7000 psi), although the amount of material removed increased at a greater rate with increasing pressure with the 90 degree jets. Figure 8 illustrates this data.

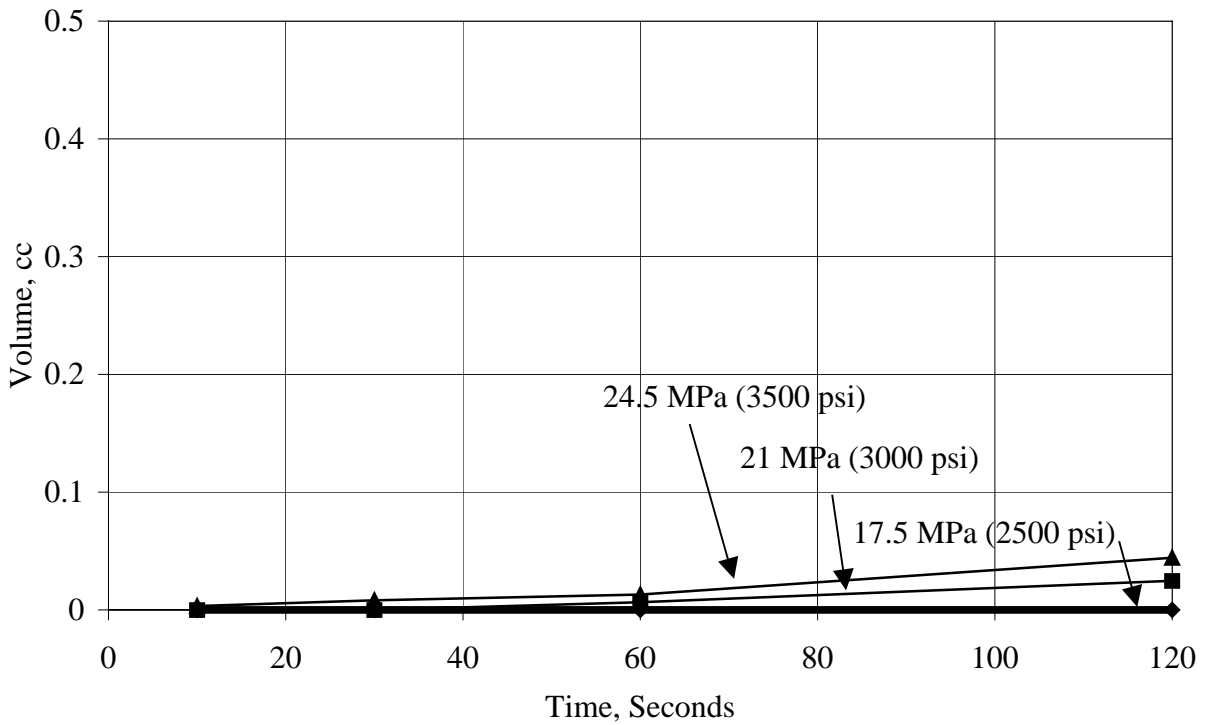
**Effect of Time and Pressure with 135 Degree Jets on Vitrified Clay Pipe  
Figure 10.**

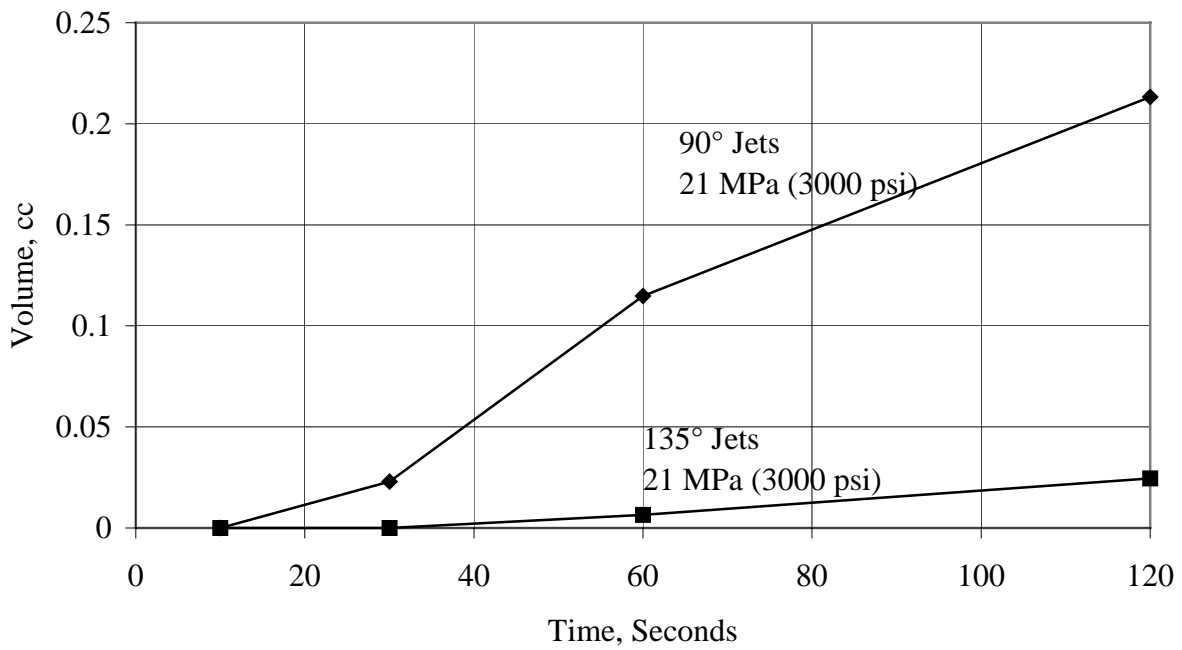
**Effect of Angle and Time on Vitrified Clay Pipe  
Figure 12.**
